**Test Report**

Number: 221101788SHA-001

**ISTA 6 - Amazon.com – SIOC – A Test Report\_External**  
**VERSION DATE: 5/9/2018**

Vendor/Seller Name: Snow Joe,LLC  
ASIN: B079Z1YL1Q  
Item: Reel Mower\MJ503M

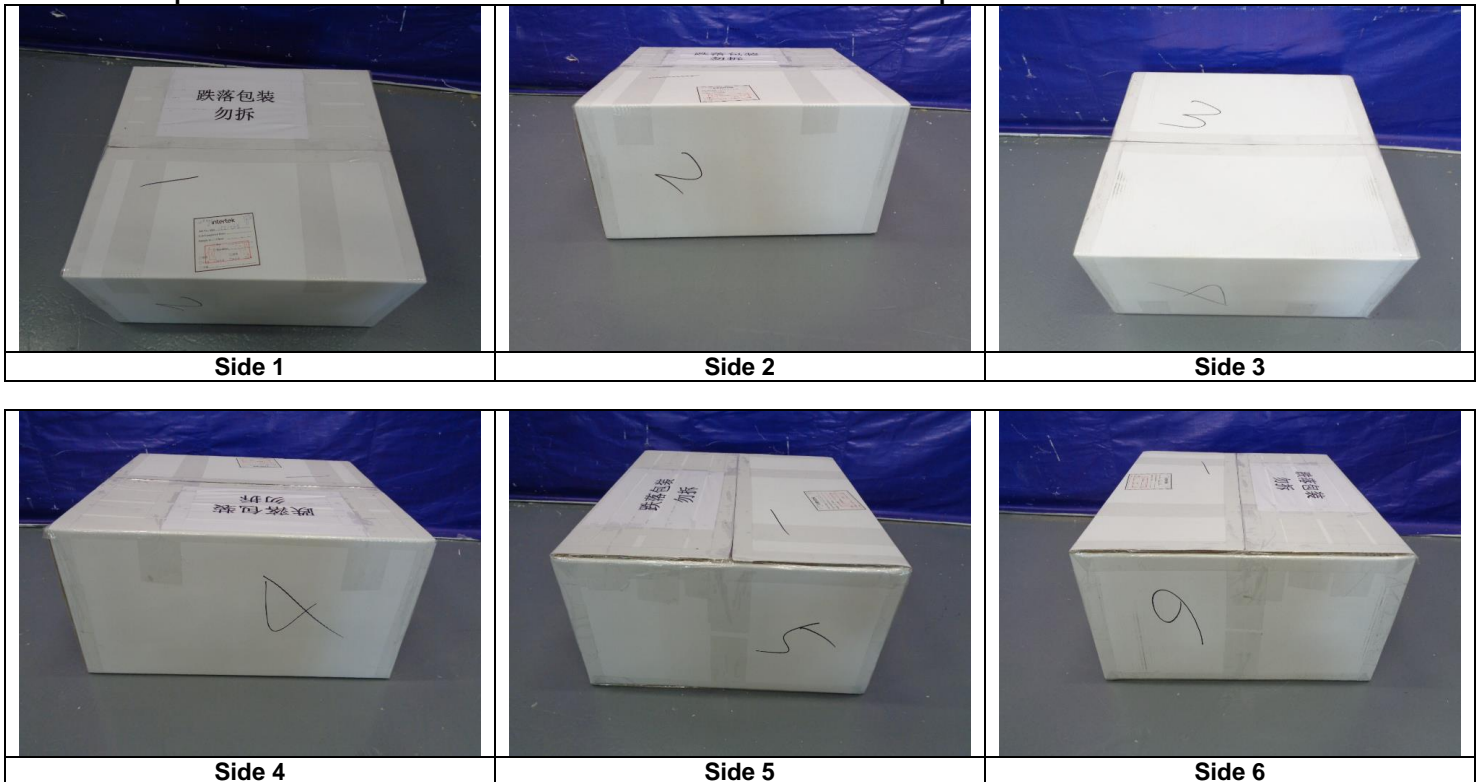
**PRE-TEST PICTURES**

<b>Product Condition</b>	Package was not opened before testing to review product
<b>Package Condition</b>	Package was not opened before testing and the carton box was in good condition.
<b>Package Condition before testing</b>	<input checked="" type="checkbox"/> ORIGINAL as arrived in the lab for testing <input type="checkbox"/> NEW re-packaged with new materials before testing
<b>Corrugated Info (Box Cert if available)</b>	N/A Actual BST by lab:125PSI(D/W)
<b>Dunnage Info</b>	Master carton, plastic bag, EPE, pulp edge protector
<b>Additional Notes</b>	N/A

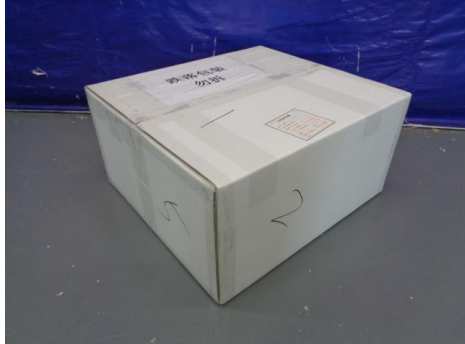
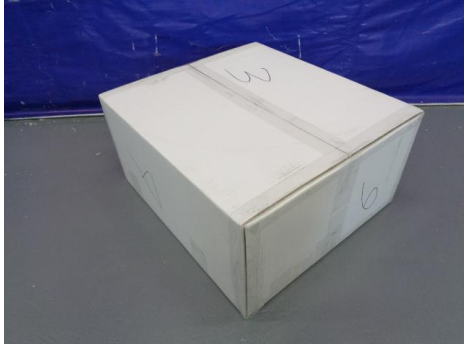
<b>Box Cert (If Applicable)</b>	<b>ISO #1 Side 1/2/5</b>	<b>ISO #2 Sides 3/4/6</b>

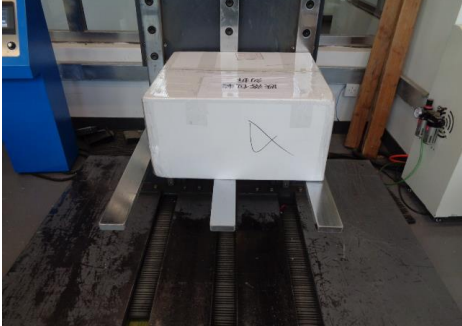
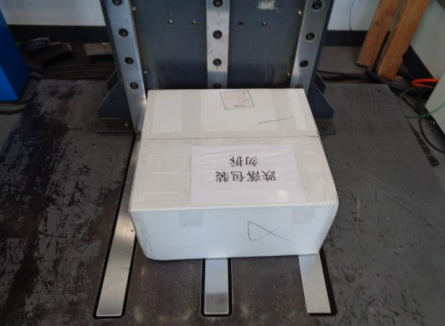
<p>NA</p>
<p><b>Block 2 Drop 9 Test Set Up</b></p>	<p><b>Block 2 Drop 9 Post Test Item Picture</b></p>	<p><b>Extra #</b></p>

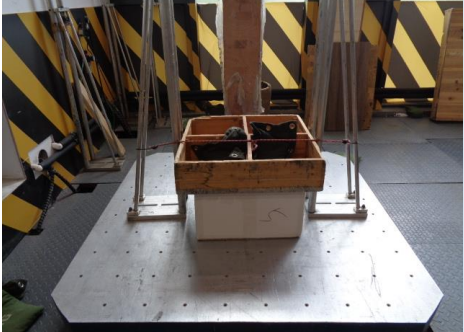
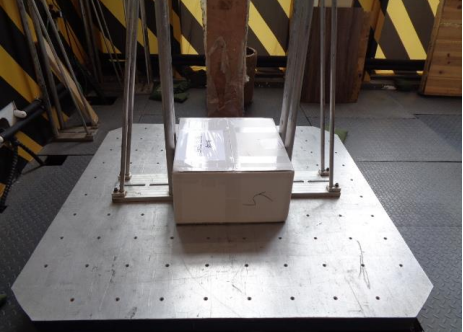
<p><b>Block 12 Face 3 Test Set up</b></p>	<p><b>Block 12 Face 3 Post Test Item Picture</b></p>	<p><b>Block 12 Face 3 Test Vibration Profile</b></p>

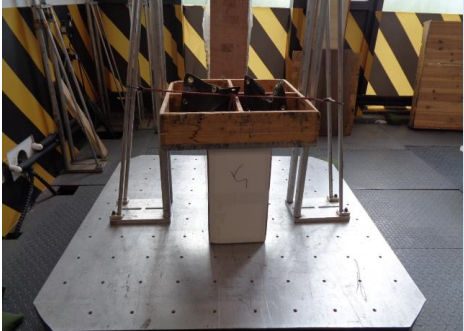
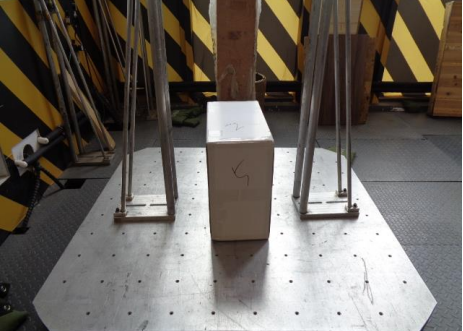
<p><b>Block 12 Face 4 Test Set up</b></p>	<p><b>Block 12 Face 4 Post Test Item Picture</b></p>	<p><b>Block 12 Face 4 Test Vibration Profile</b></p>

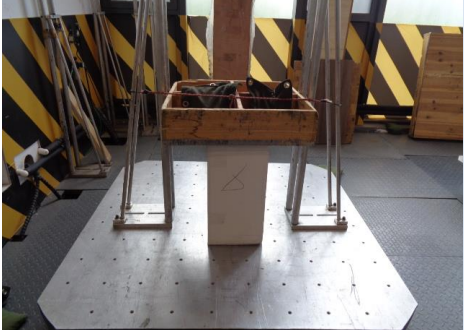
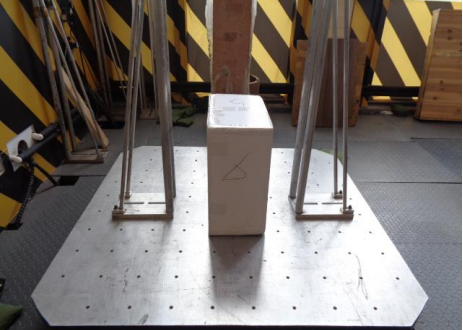
<p><b>Block 12 Face 6 Test Set up</b></p>	<p><b>Block 12 Face 6 Post Test Item Picture</b></p>	<p><b>Block 12 Face 6 Test Vibration Profile</b></p>

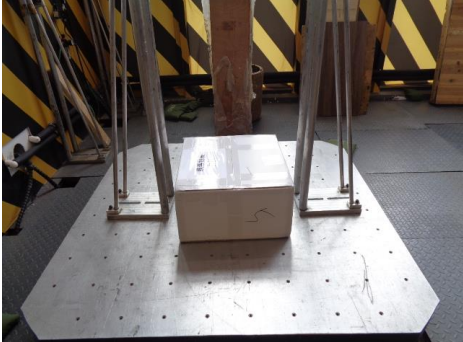
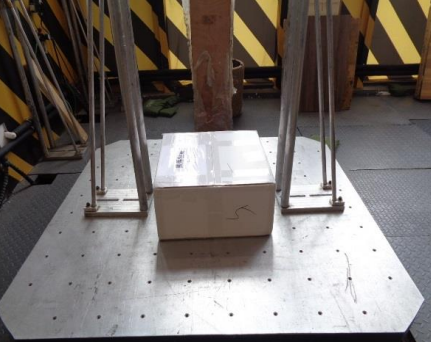
<p><b>Block 12 Face 3 (Pick-Up) Test Set up</b></p>	<p><b>Block 12 Face 3 Post Test Item Picture</b></p>	<p><b>Block 12 Face 3 Test Vibration Profile</b></p>

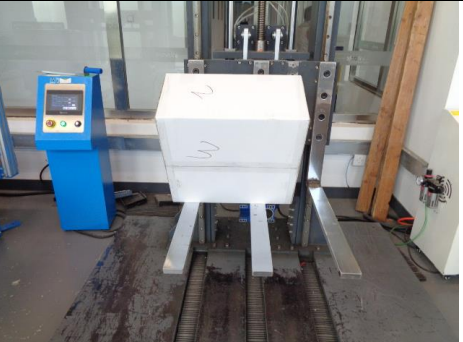
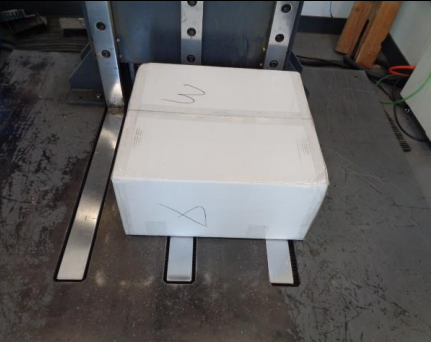
<p>NA</p>
<p><b>Block 15 Drop 10-15 Test Set Up</b></p>	<p><b>Block 15 Drop 10-15 Post Test Item Picture</b></p>	<p><b>Extra #</b></p>

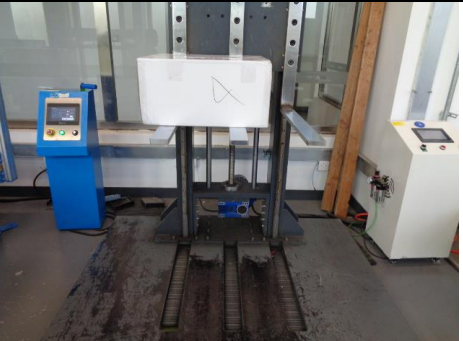
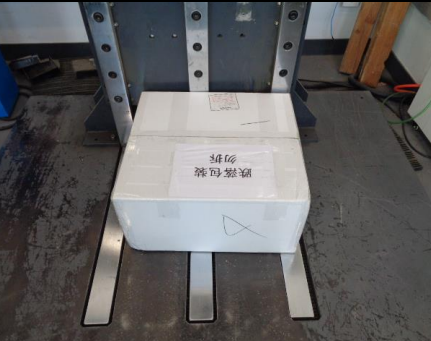
<p>NA</p>
<p><b>Block 15 Drop 16 Test Set Up</b></p>	<p><b>Block 15 Drop 16 Post Test Item Picture</b></p>	<p><b>Extra #</b></p>

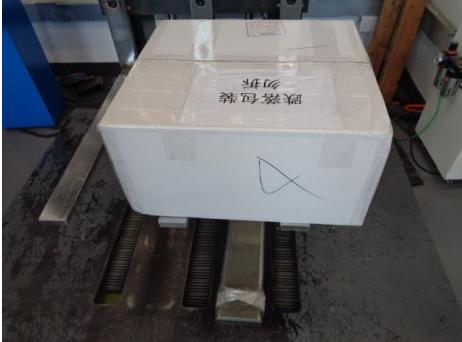
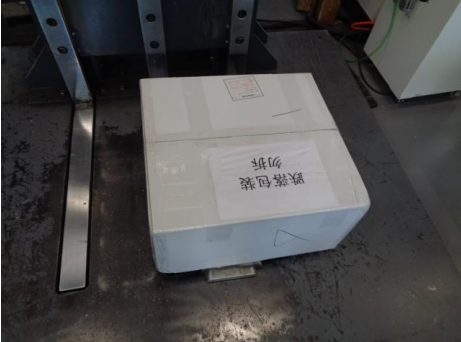
<p>NA</p>
<p><b>Block 15 Drop 17 Test Set Up</b></p>	<p><b>Block 15 Drop 17 Post Test Item Picture</b></p>	<p><b>Extra #</b></p>
<p>NA</p>	<p>NA</p>	<p>NA</p>
<p><b>Block 21 Test Set Up</b></p>	<p><b>Block 21 Post Test Item Picture</b></p>	<p><b>Extra #</b></p>
<p>NA</p>	<p>NA</p>	<p>NA</p>
<p><b>Block 22 Test Set Up</b></p>	<p><b>Block 22 Post Test Item Picture</b></p>	<p><b>Extra #</b></p>
<p>NA</p>	<p>NA</p>	<p>NA</p>
<p><b>Block 23 Test Set Up</b></p>	<p><b>Block 23 Post Test Item Picture</b></p>	<p><b>Extra #</b></p>

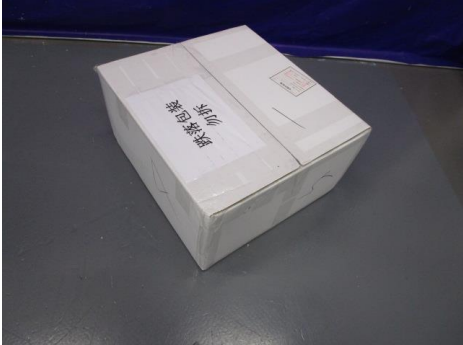
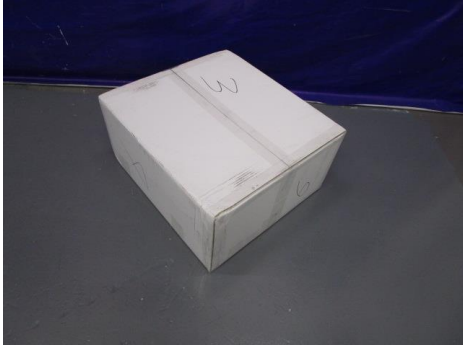
<b>Overview</b>	The package Passed the packaging test criteria with no visible damage noted per ISTA 6-Amazon.com-SIOC-Type A.
<b>Product Condition</b>	The product inside the carton box was not damaged after testing.
<b>Packaging Condition</b>	The packaging materials inside the carton box were not damaged after testing

NA
<b>ISO #1 Side 1/2/5</b>	<b>ISO #2 Sides 3/4/6</b>	<b>Exploded BOM View</b>
